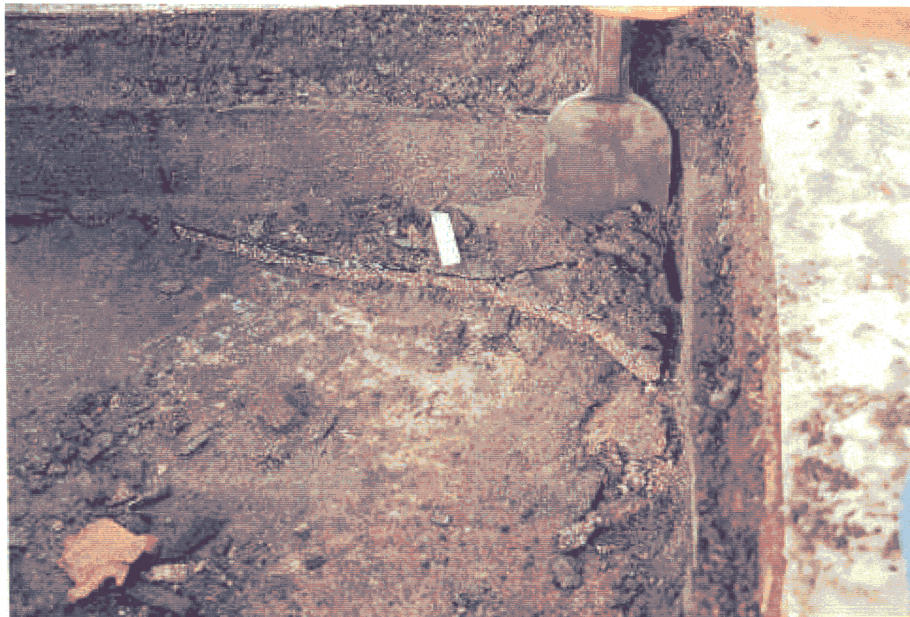
Figure 2.6-22 Inspection Opening No. 3

- g. Approximately 1/2-inch thick layer (tapered) All-Weather Crete asphalt/perlite fill (wet).
- h. Concrete roof slab.
